Manhole Inspection Summary

Manhole # S65S__002MH

Insp Date: **3/6/08 10:56 AM**

Location Address: **1562 Elrino St.**

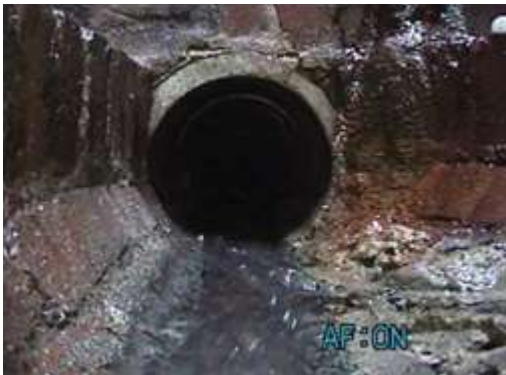
Defect 1

cracked pipe seal 10:00-2:00 outgoing 12 O'Clock

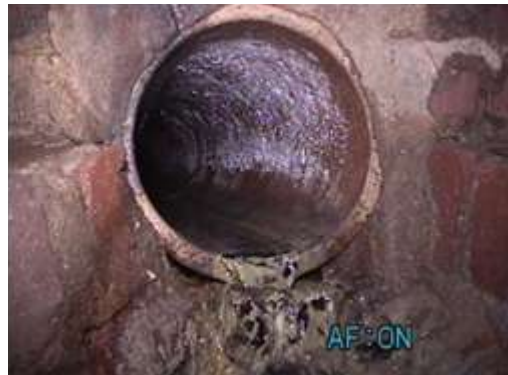
Defect 2

cracked pipe seal 5:00-7:00 incoming 3 O'Clock

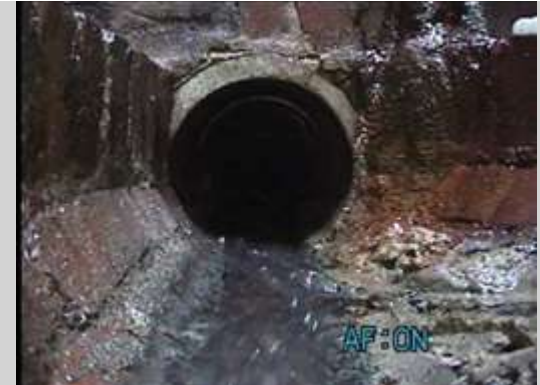
12 O'Clock Outflow

Pipe Height: **8.4** (in.) Rod and Bar (Angled)
Pipe Material: **Clay** ☐ Pipe Lined
Invert Depth: **8.08** (ft.) Flow Characteristics: **Fast**
Deposits: ☒ None ☐ Mud ☐ Sludge ☐ Debris ☐ Grease
Silt Depth: (in.) Deposits Extent:
Infiltration: **Evidence** Pipe Seal Cond: **Cracked**

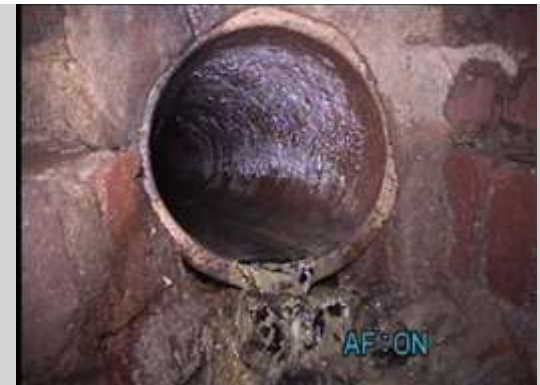
3 O'Clock Inflow

Pipe Height: **8.4** (in.) Rod and Bar (Angled)
Pipe Material: **Clay** ☐ Pipe Lined
Invert Depth: **7.54** (ft.) Flow Characteristics: **Fast**
Deposits: ☒ None ☐ Mud ☐ Sludge ☐ Debris ☐ Grease
Silt Depth: (in.) Deposits Extent:
Infiltration: **None** Pipe Seal Cond: **Sound**

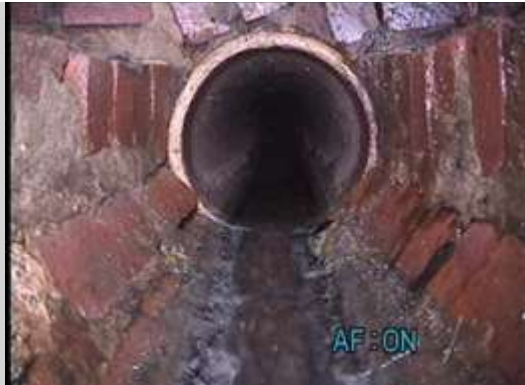
6 O'Clock Inflow

Infiltration: **None** Pipe Seal Cond: **Sound**
